# EPA REGION 10 PREVENTION/PREPAREDNESS/ RESPONSE

Alaska Regional Response Team  
Juneau Meeting  
January 28, 2015

## MP 48 RICHARDSON HIGHWAY DIESEL DISCHARGE

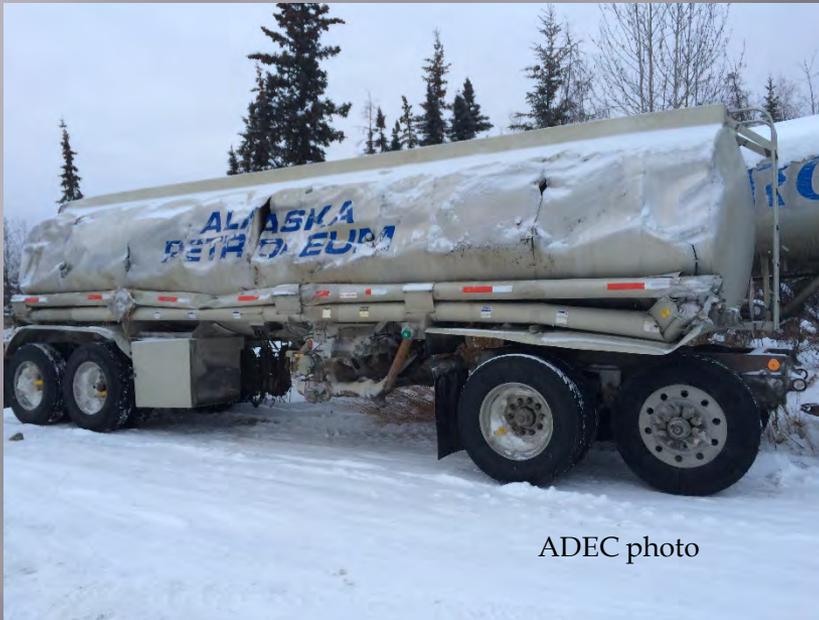
ADEC photo

On December 09, 2014 a “pup” tanker rolled over on the Richardson Highway at MP 48 discharging its contents.

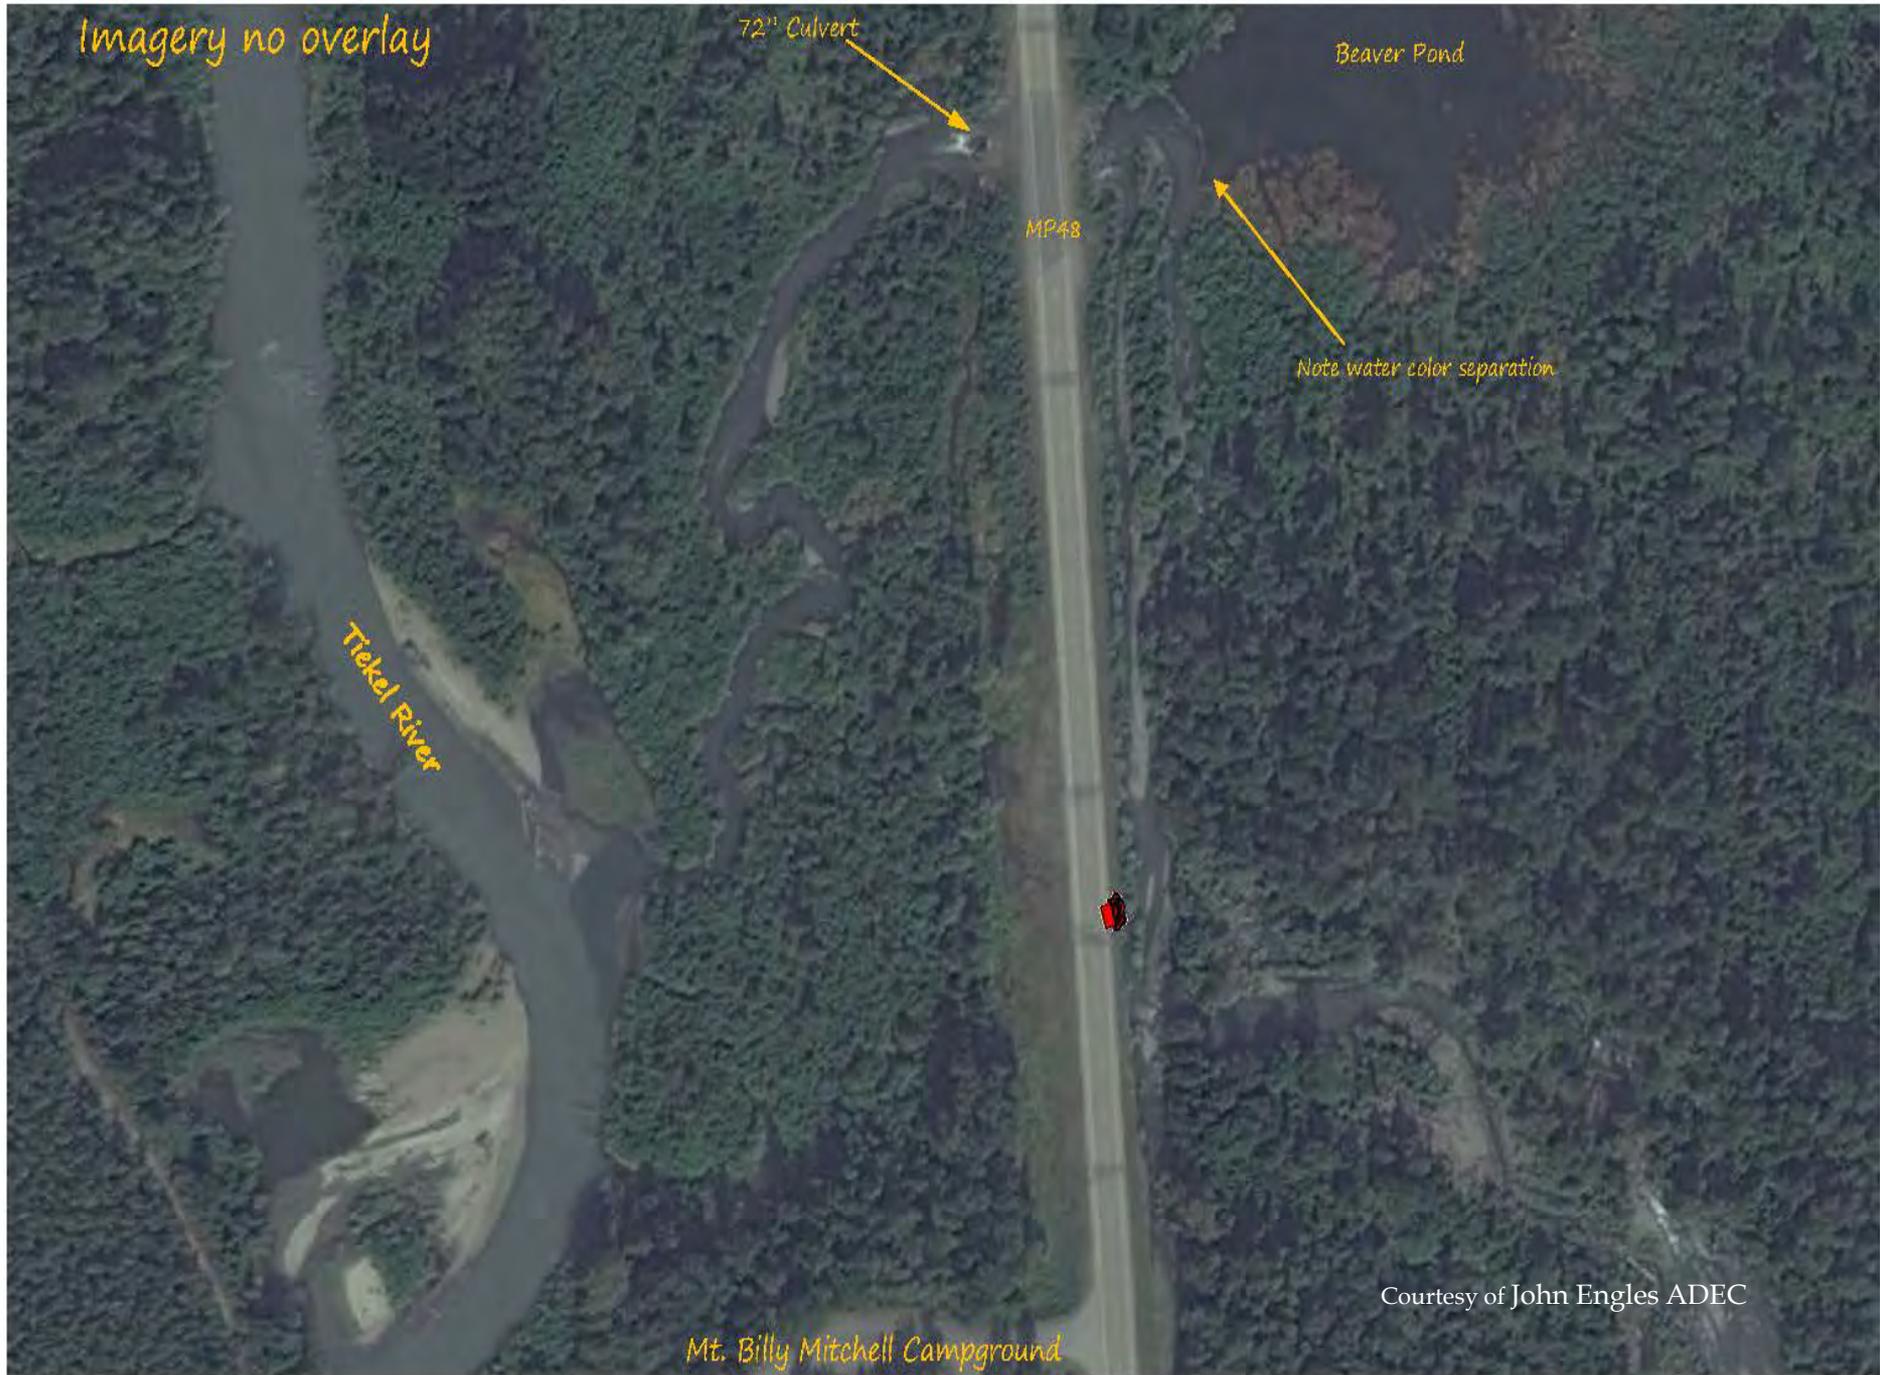
Imagery no overlay

72" Culvert

Beaver Pond

MP48

Note water color separation

Tickel River

Mt. Billy Mitchell Campground

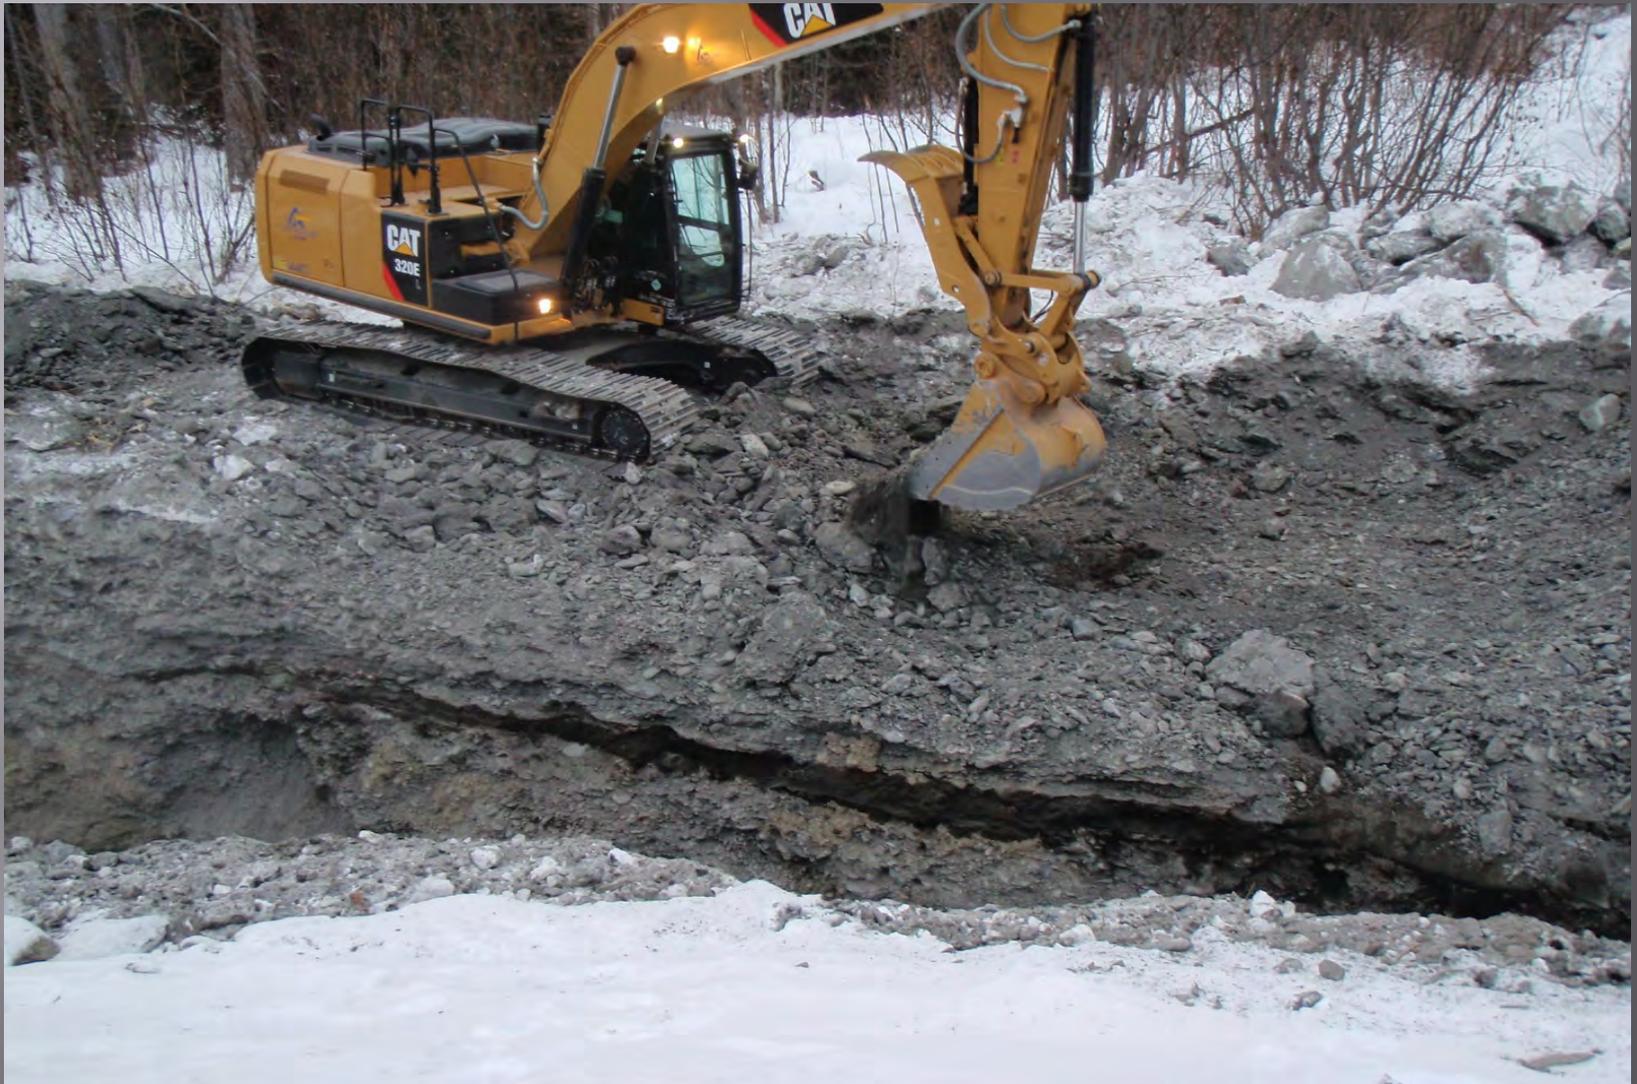
## Excavation Operations *"Note contaminated sill"*

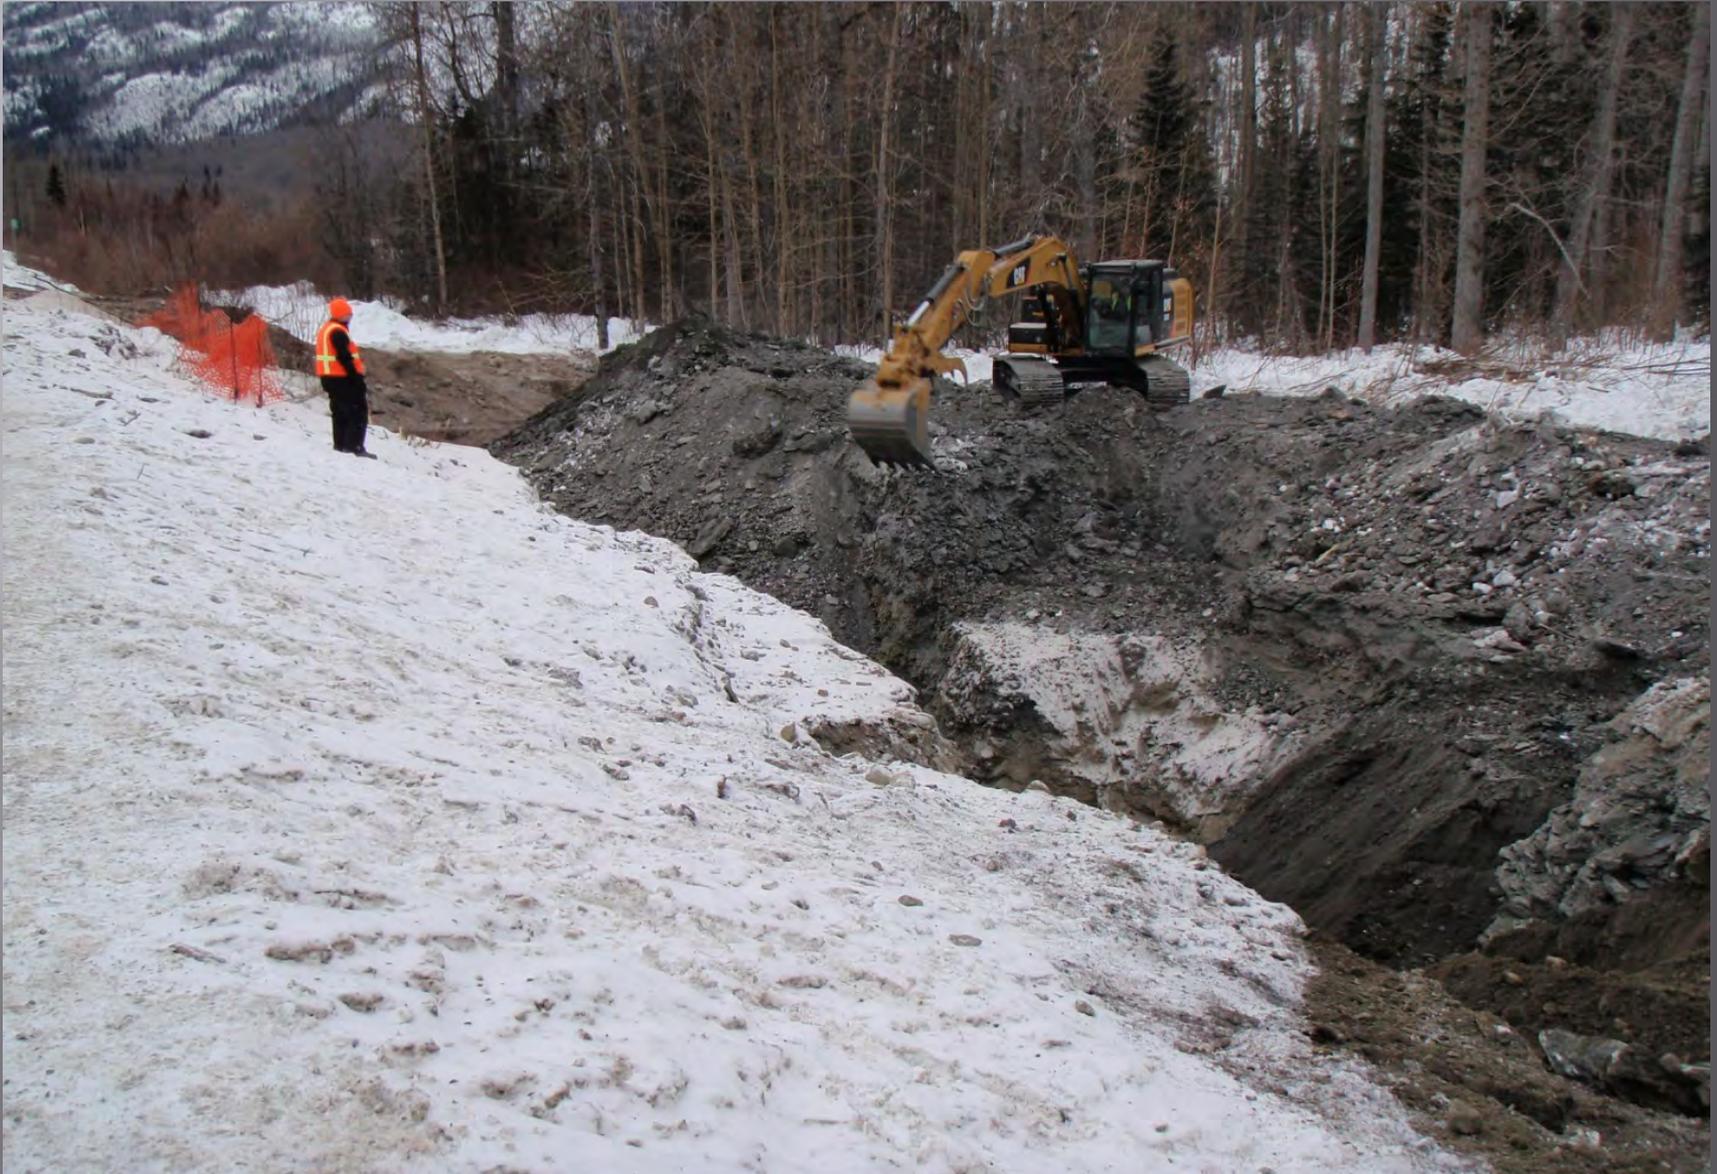
## “Benching” to Access Contamination at Depth
